Review of US Historical Rocket Propellants: Accidents, Mishaps & Fatalities

Eric J Wernimont* and Mark C Ventura†
General Kinetics Inc., Huntington Beach, CA, 92649

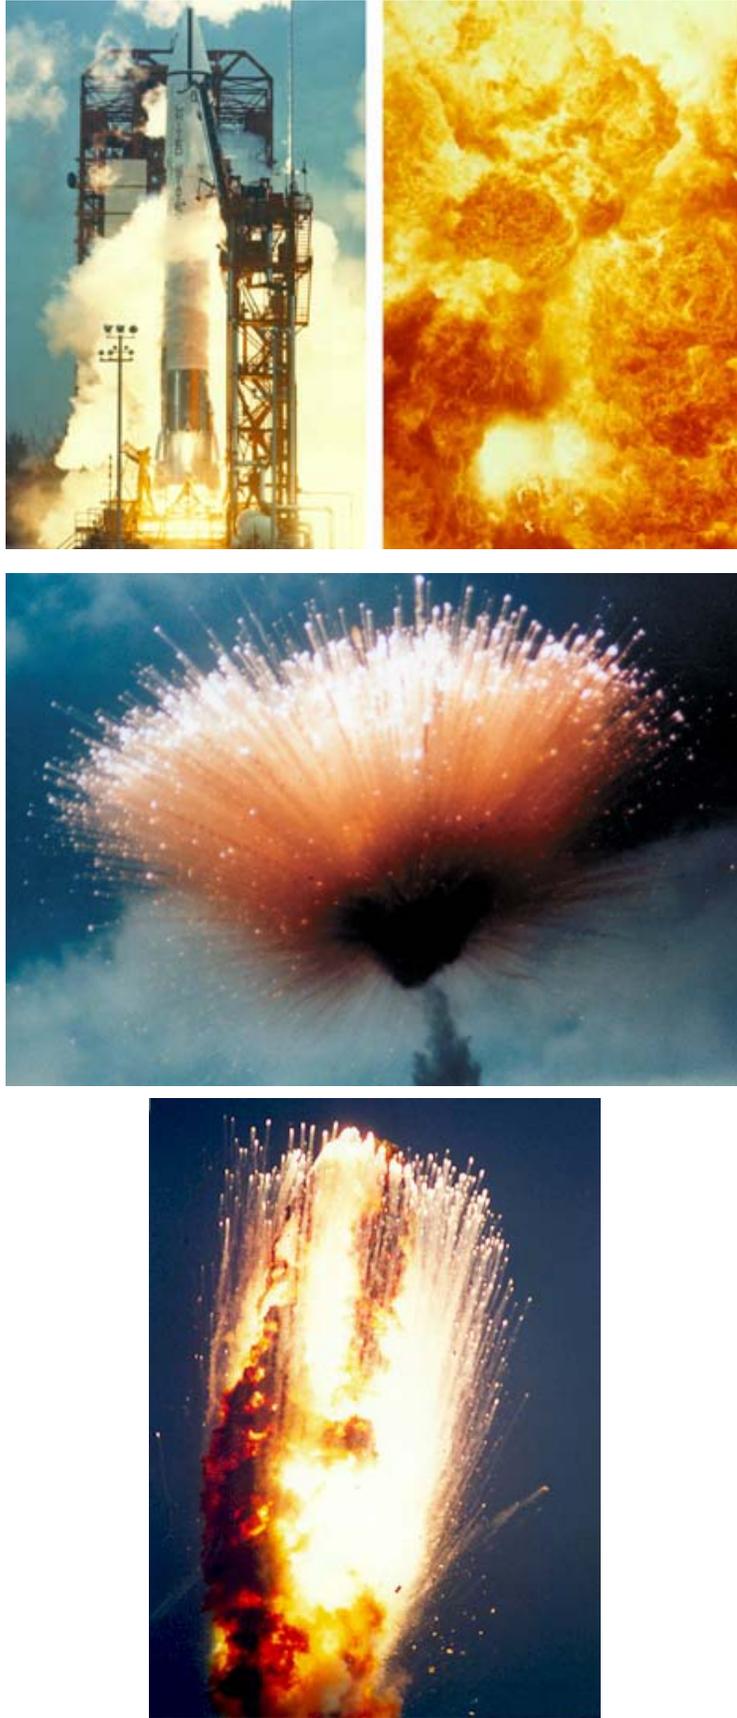
Figure 1. US Launch Vehicle Failures – Atlas, Delta & Titan (Top to Bottom)¹²⁻¹⁴
