NASA TR R-252

SYNCOM ENGINEERING REPORT

VOLUME II

*by Syncom Projects Office
Goddard Space Flight Center
Greenbelt, Md.*

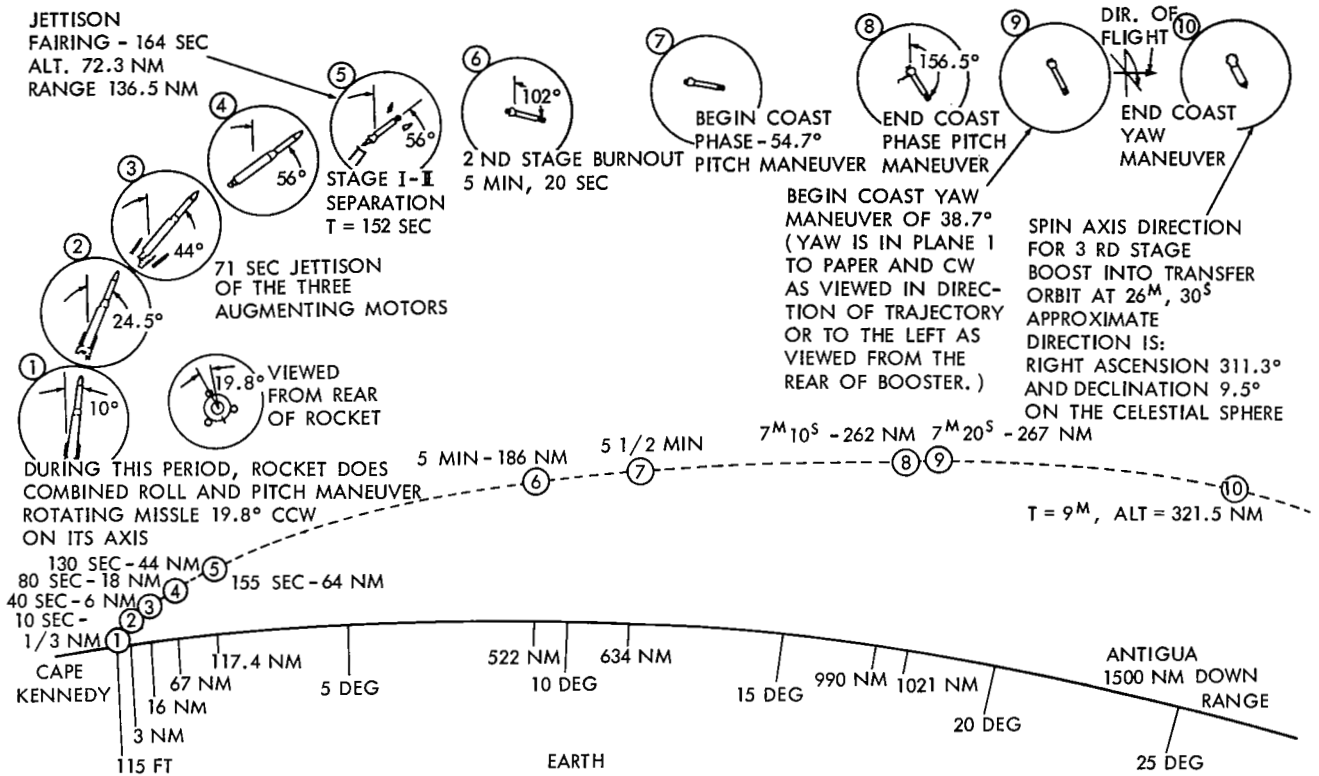
Figure III-3—Delta rocket maneuvers for Syncom III launch.

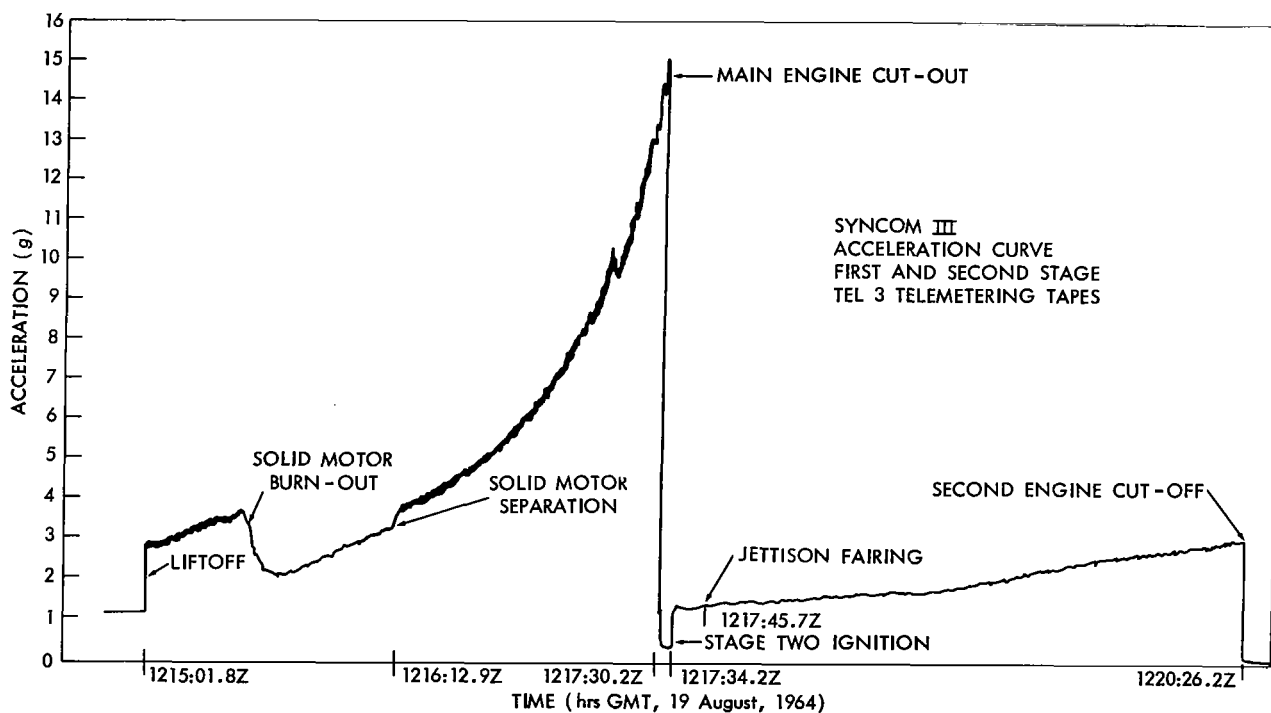
Figure III-5—Acceleration history of first- and second-stage firings.

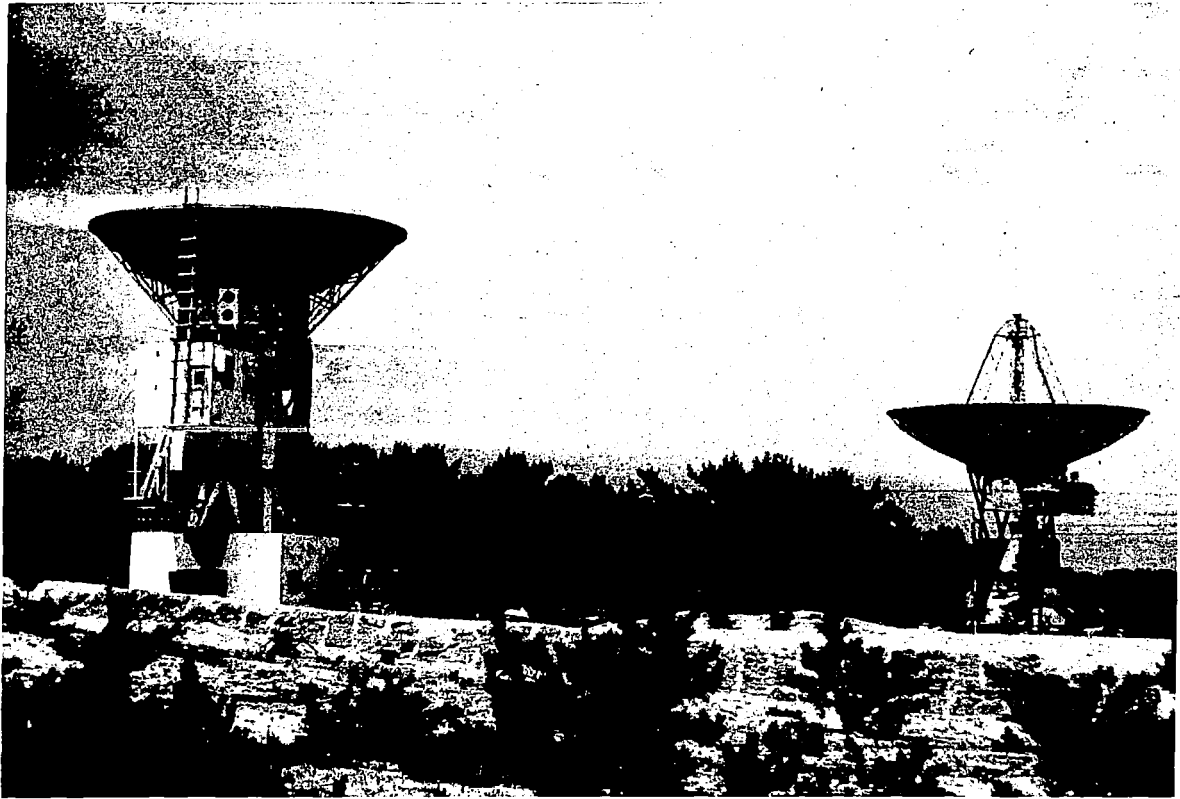
Figure VI-3—Transmitting site at Kashima (10-meter transmitting antenna at left; 30-meter receiving antenna at right).

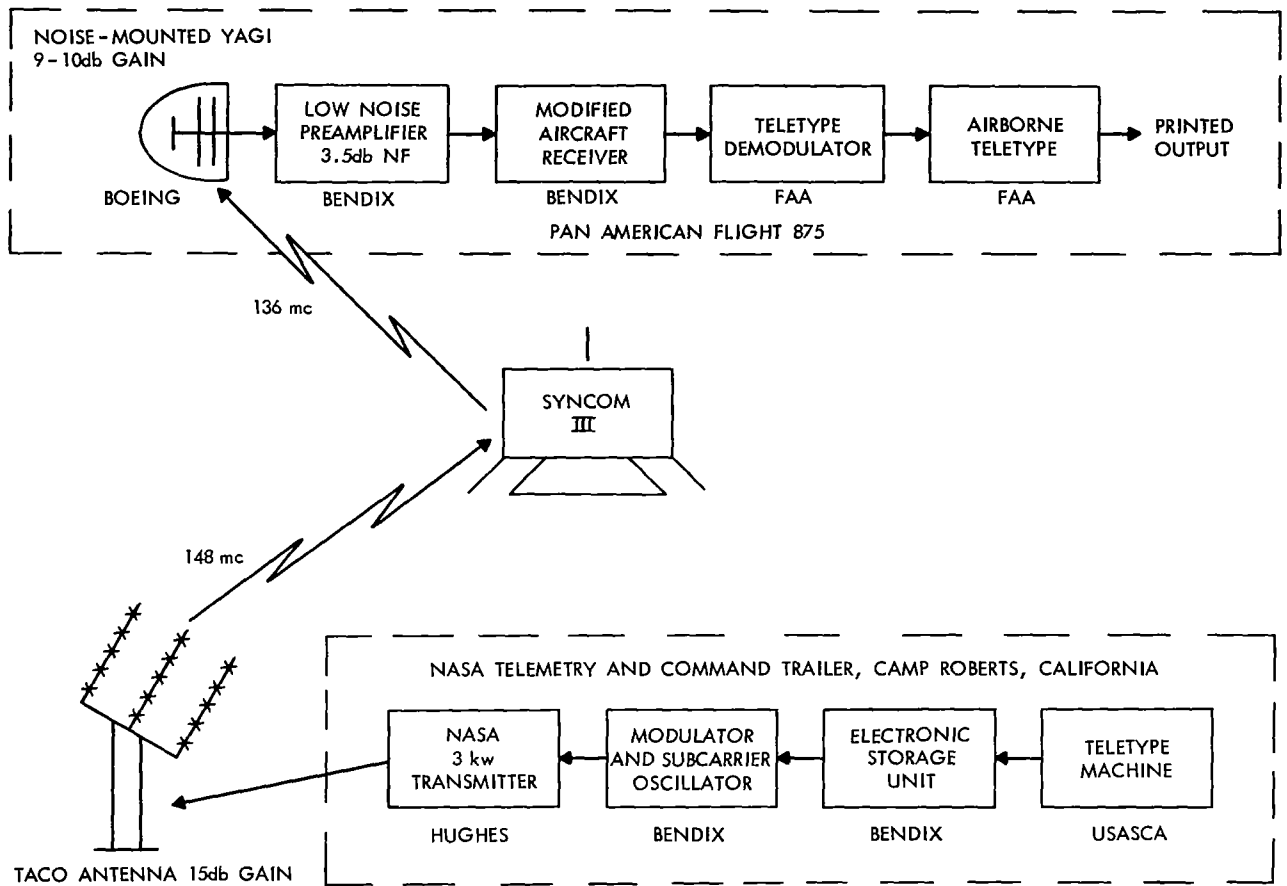
Figure VII-6--Satellite to aircraft communications test block diagram.
